Table 1
Preliminary Soil Confirmation Analytical Results
Moline Street PCB Site , Aurora, CO

TO: Joyel Dhieux, On-Scene Coordinator for EPA - Region VIII

Subject: Moline Street PCB Site – Double Tee Wall Foundation Test Pad

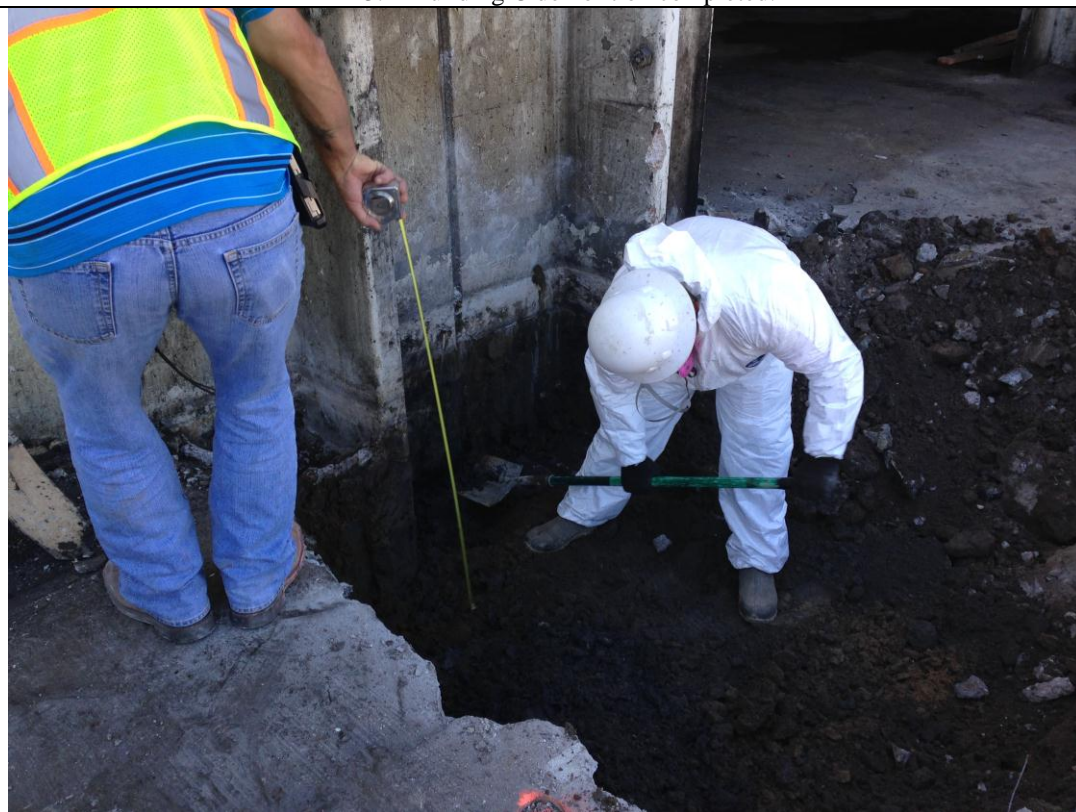
4. Building D foundation test pad.

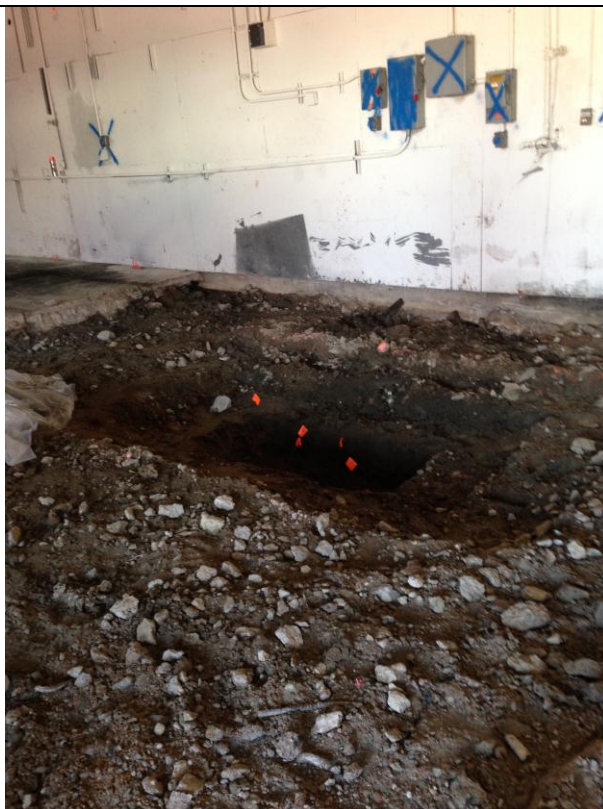
11. Excavation 1 (Building B) – orange flags show sample locations.

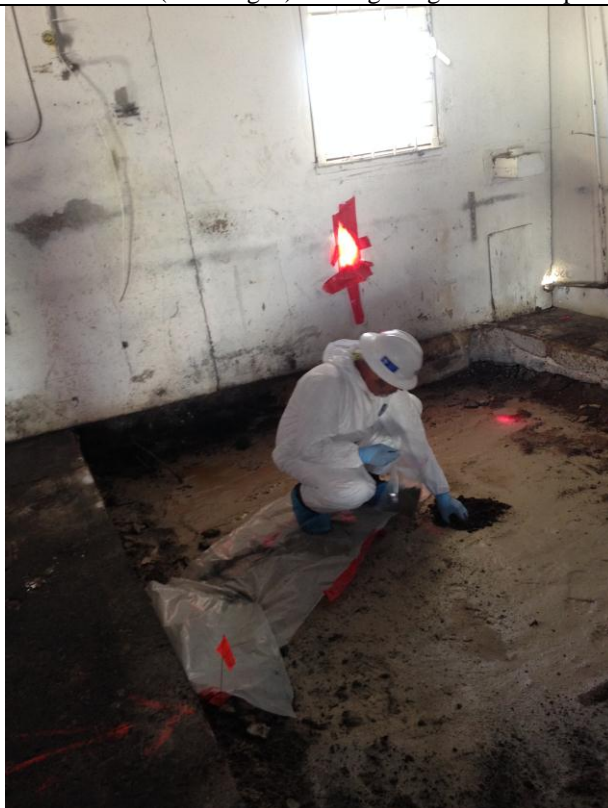
12. Excavation 2 (Building D) sampling – orange flags show sample locations.

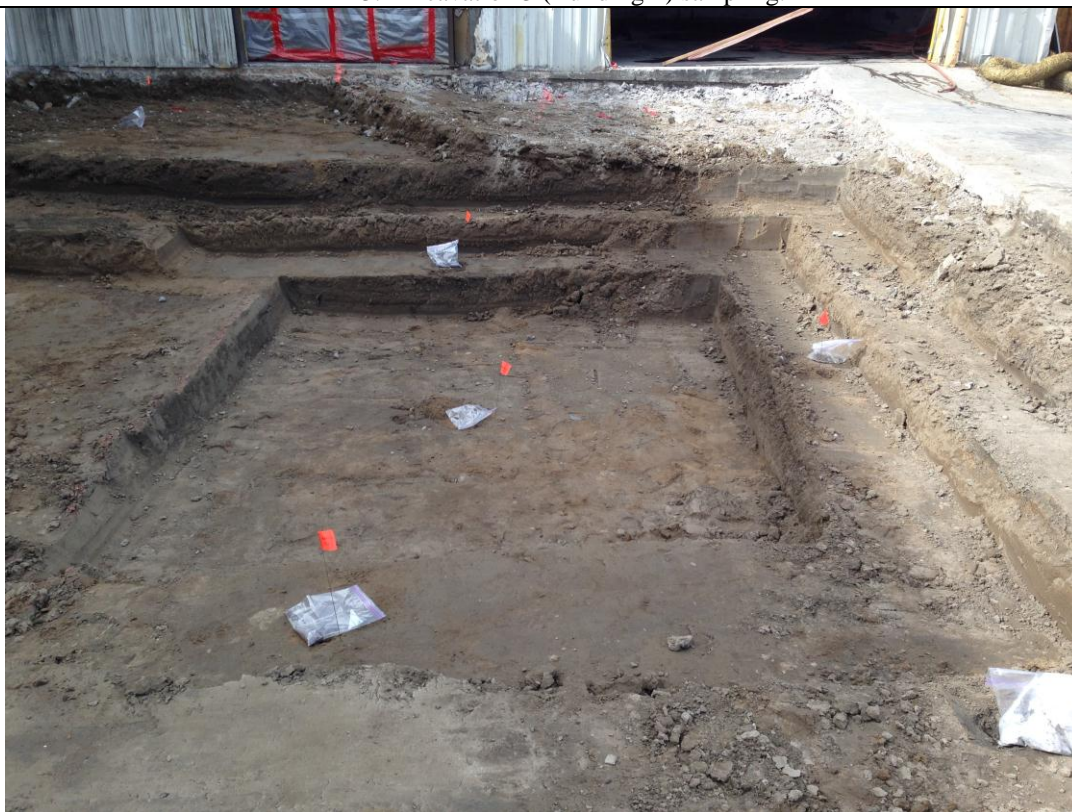
14. Excavation 4 (former Building C) – orange flags show sample locations.

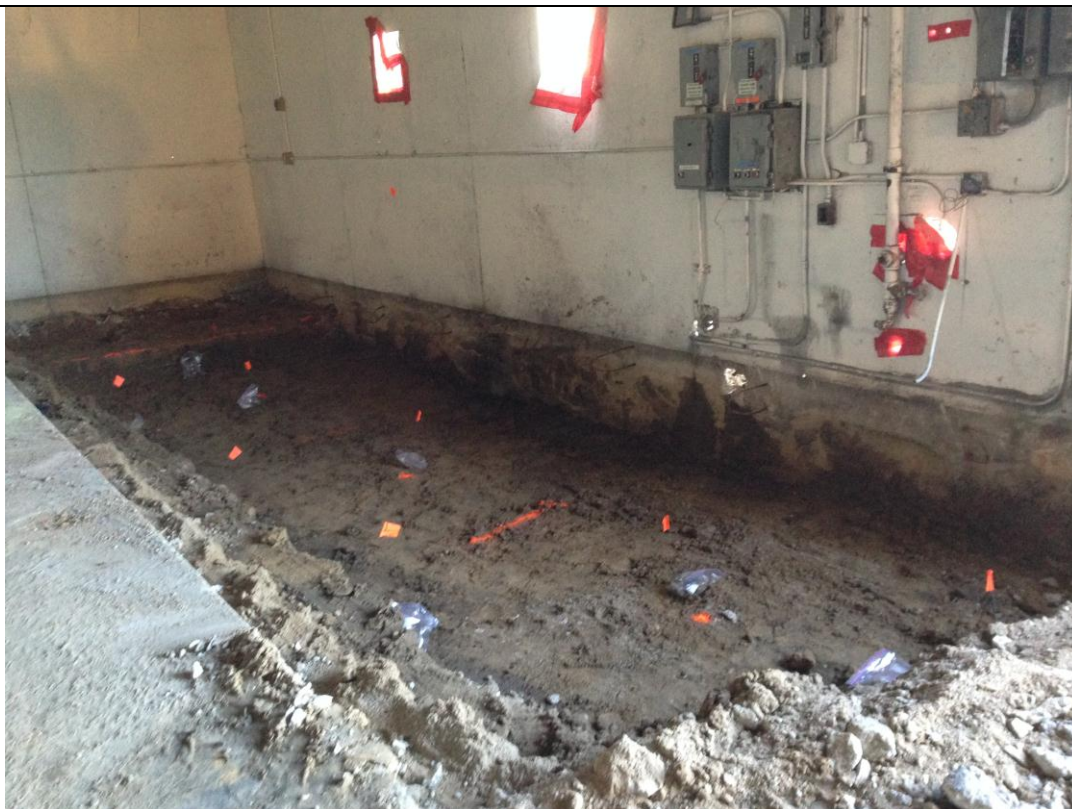
15. Excavation 5 (Building D) - orange flags show sample locations.

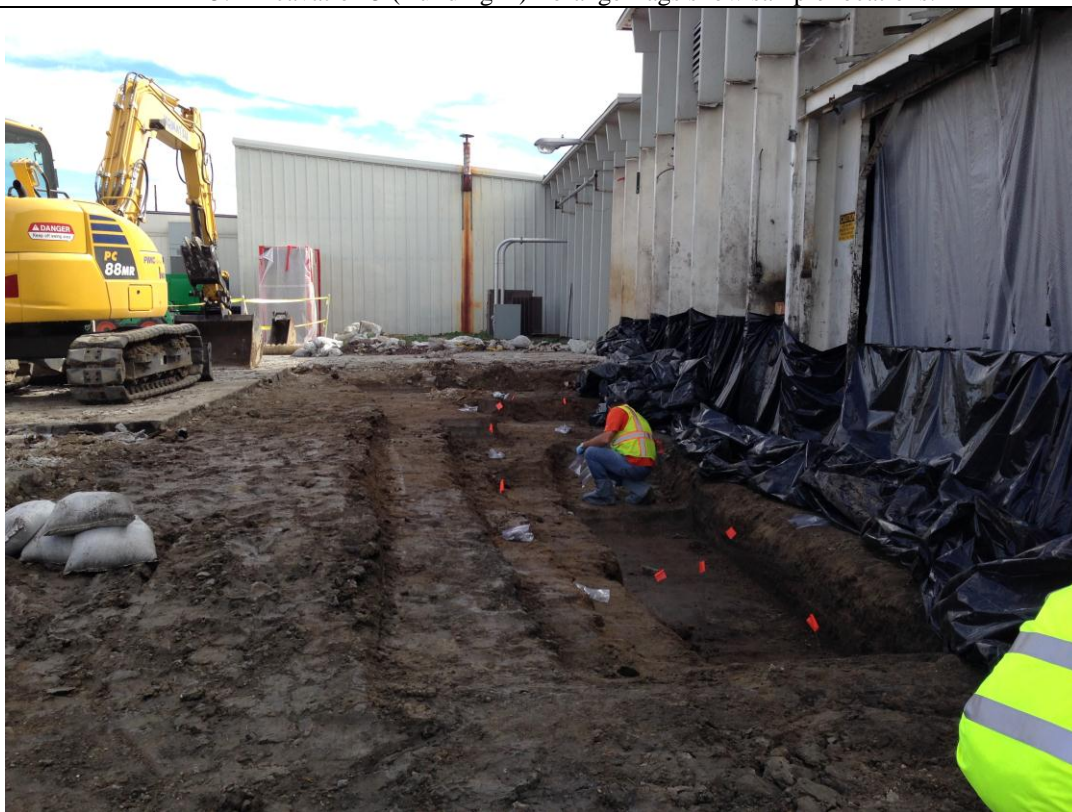
16. Excavation 6 (former Building C) - orange flags show sample locations.

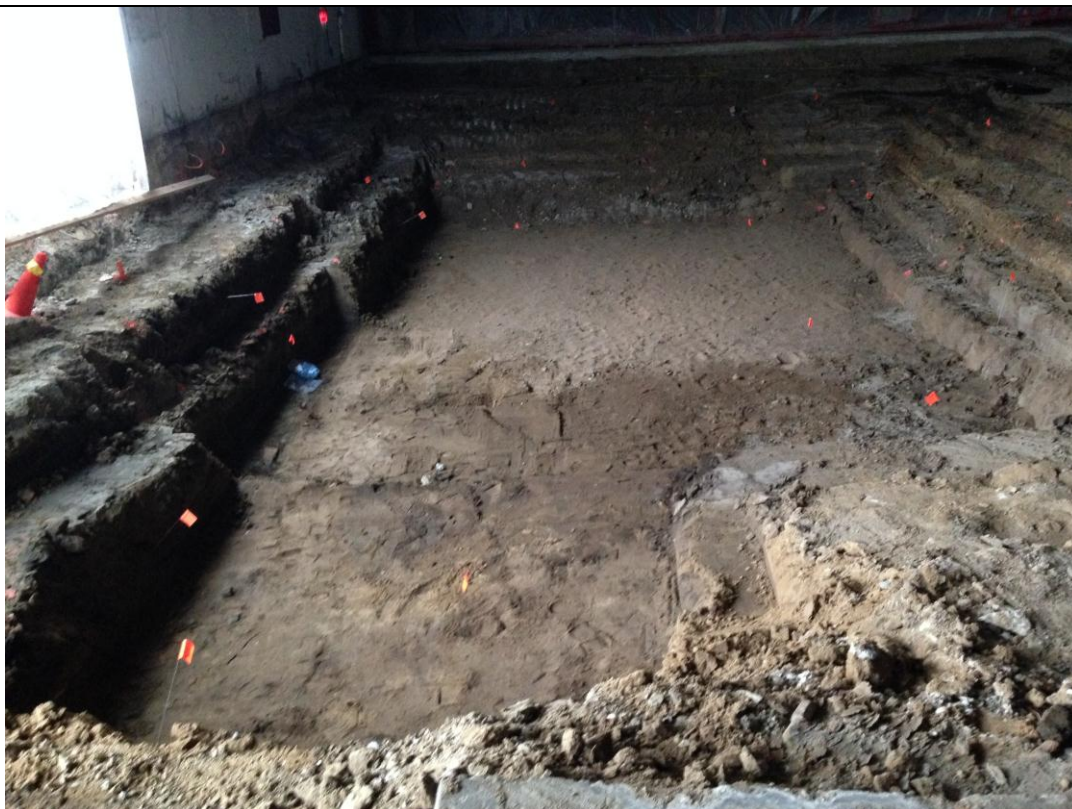
17. Excavation 7 (Building D, looking east) - orange flags show sample locations.

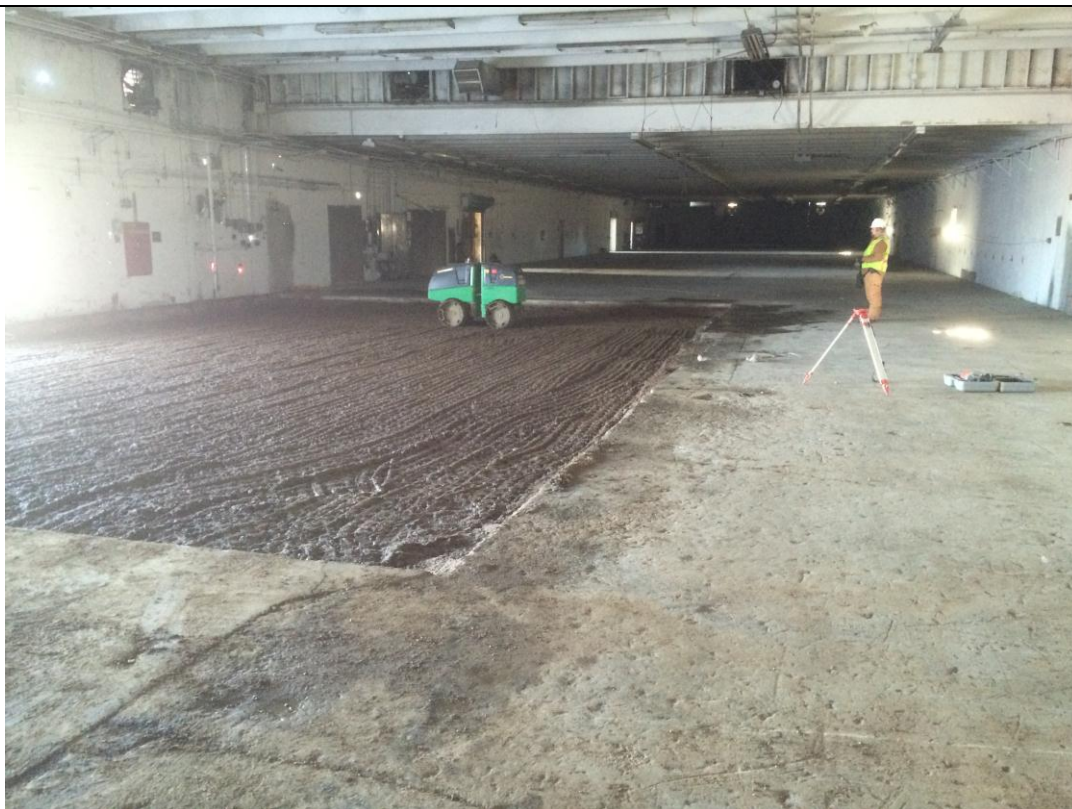
21. Compacting backfill material – Excavation 7 (Building D)

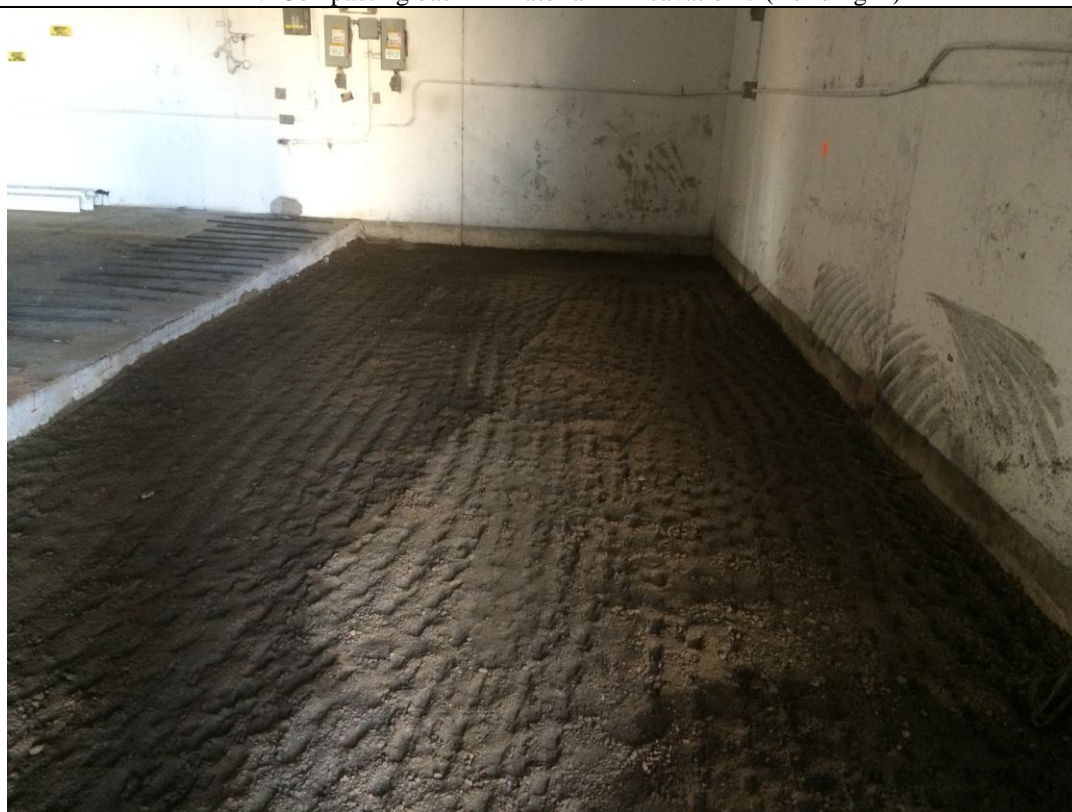
22. Compacted backfill material – Excavation 5 (Building D).

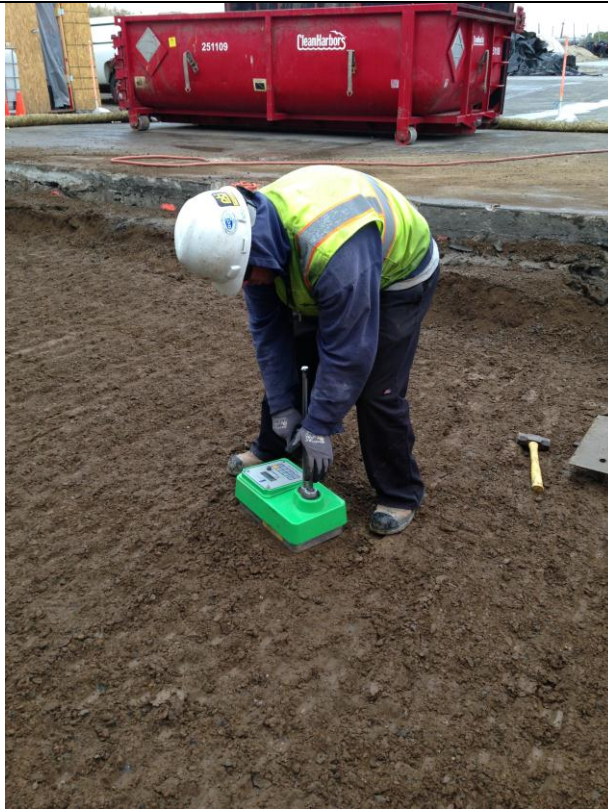
25. Compaction testing – Excavation 4 (former Building C).

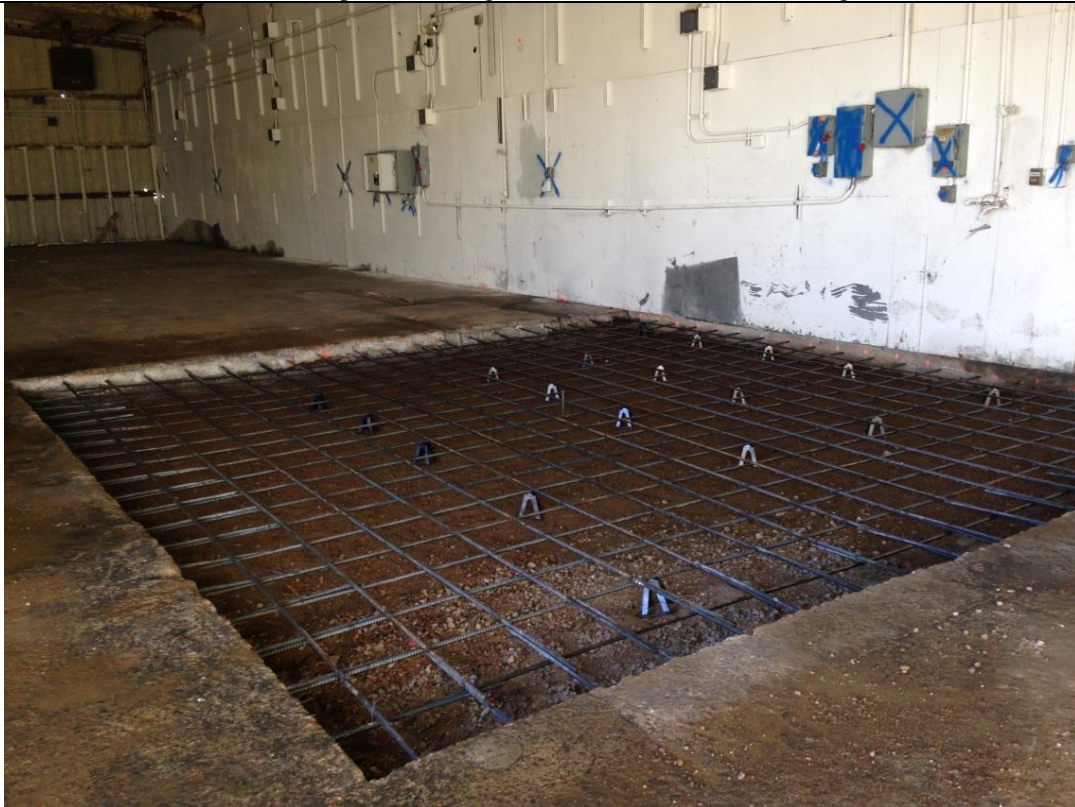
26. Excavation 1 (Building B) slab prior to concrete placement.

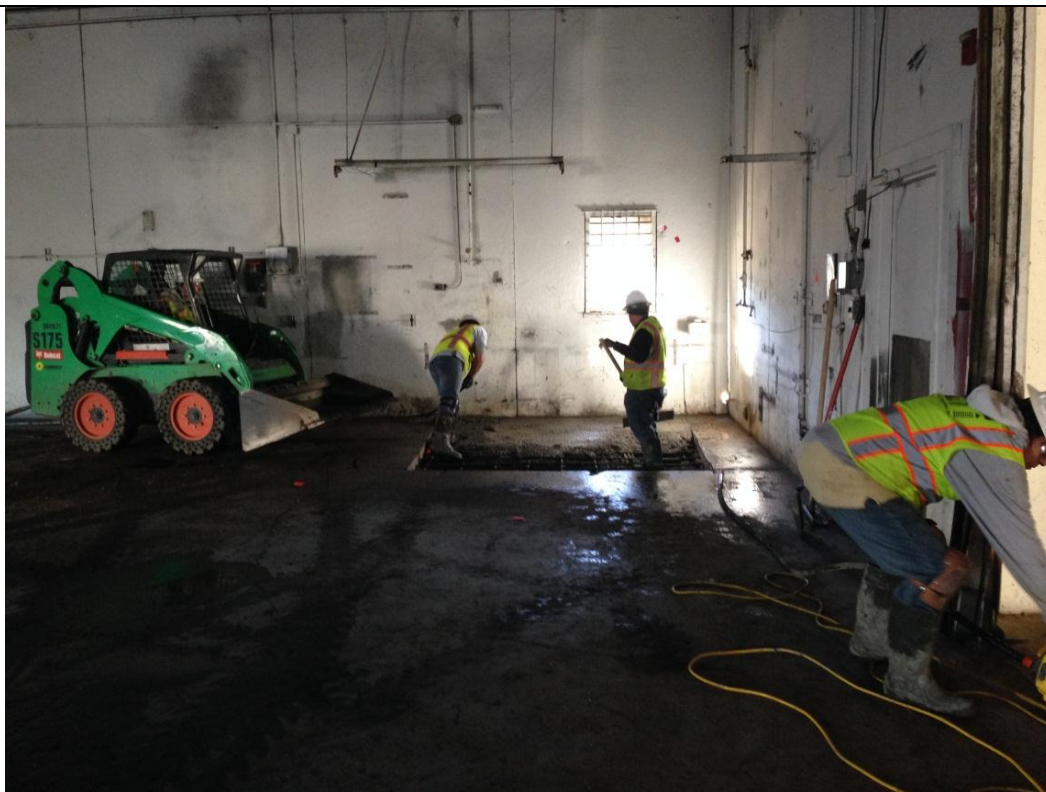
29. Placing concrete in SW corner of Building D (Excavation 2). Note use of skid steer to deliver concrete to slab location.

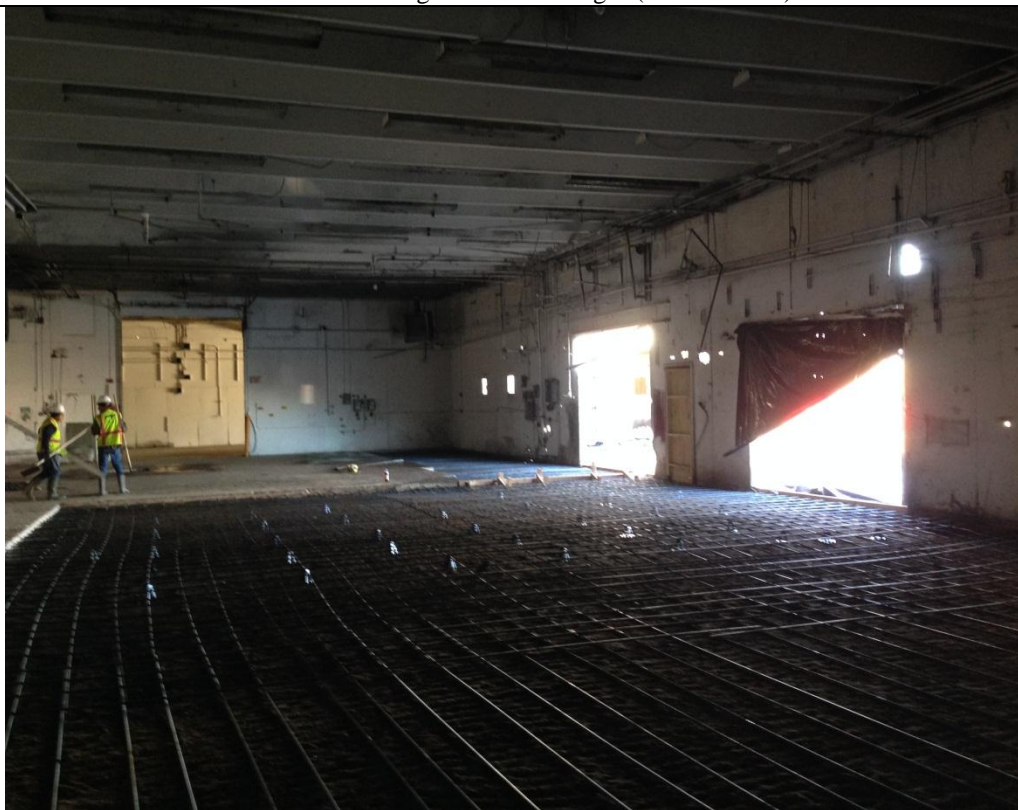
34. Building D (Excavation 7) prior to concrete placement.

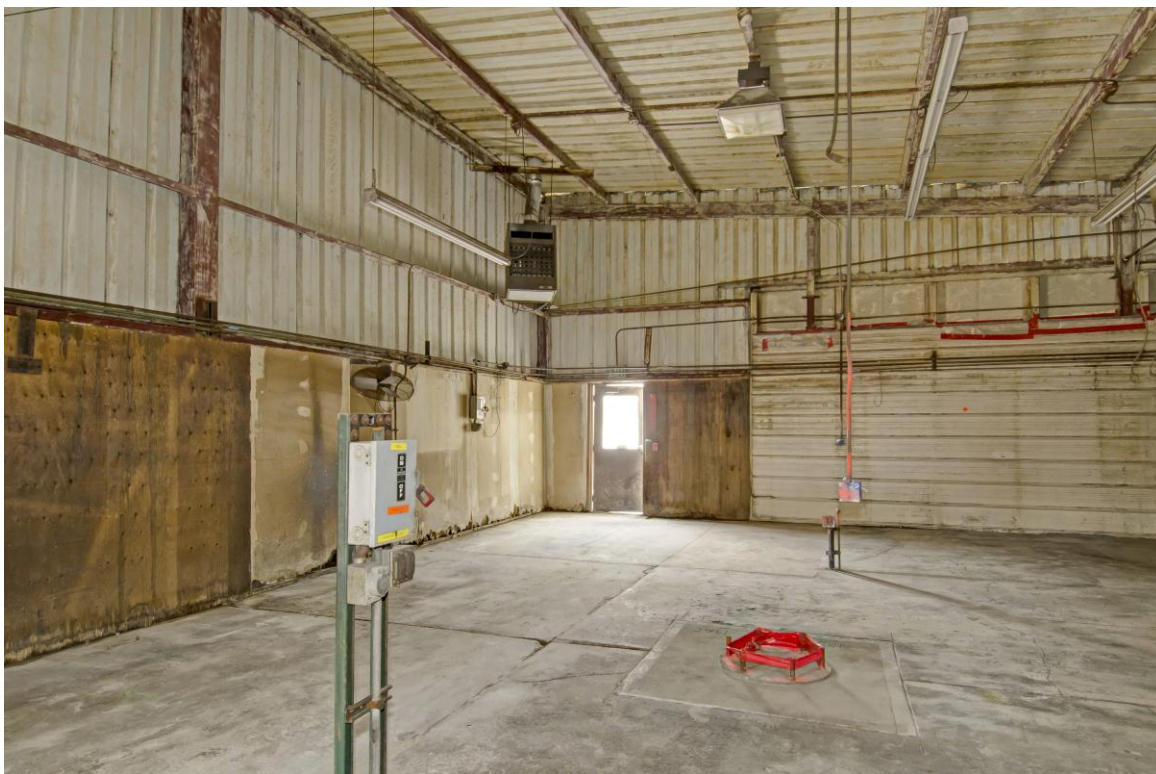
41. Building F post removal looking east. Floor feature is rebar covered with red tape for visibility - 11/20/14.

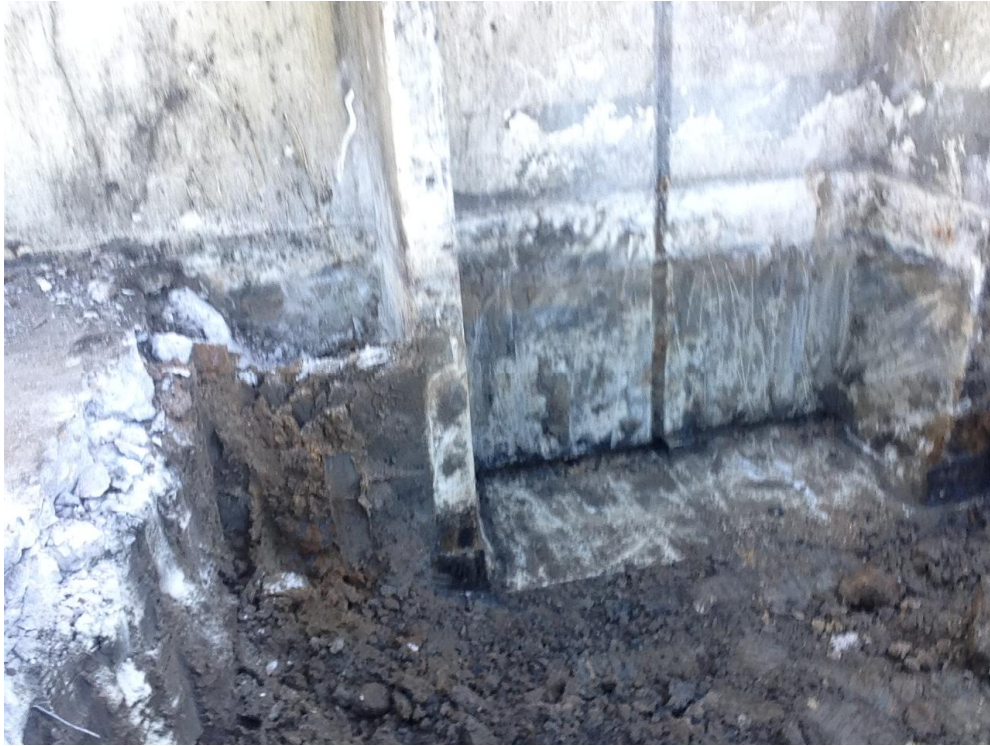
Photograph 1: View of the test pad and exposed top of footing on the exterior of the building (photo taken facing south).

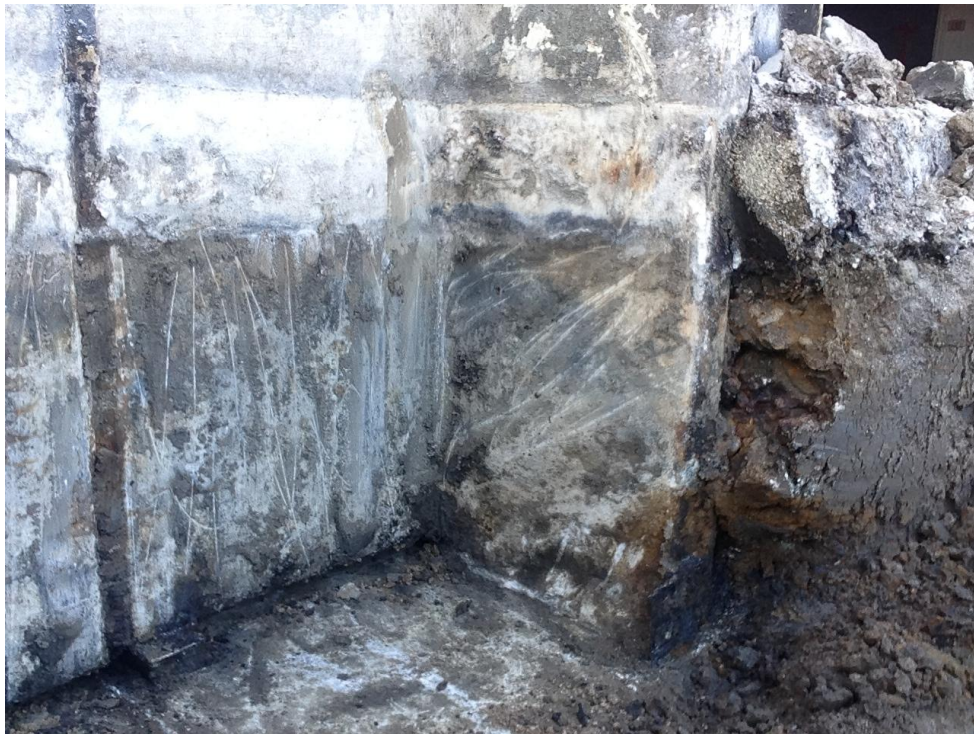
Photograph 2: Right side of test pad with the intermediate support shown in the center of the photo and the embedded plate at the tee support on the right side of the photo (photo taken facing south).

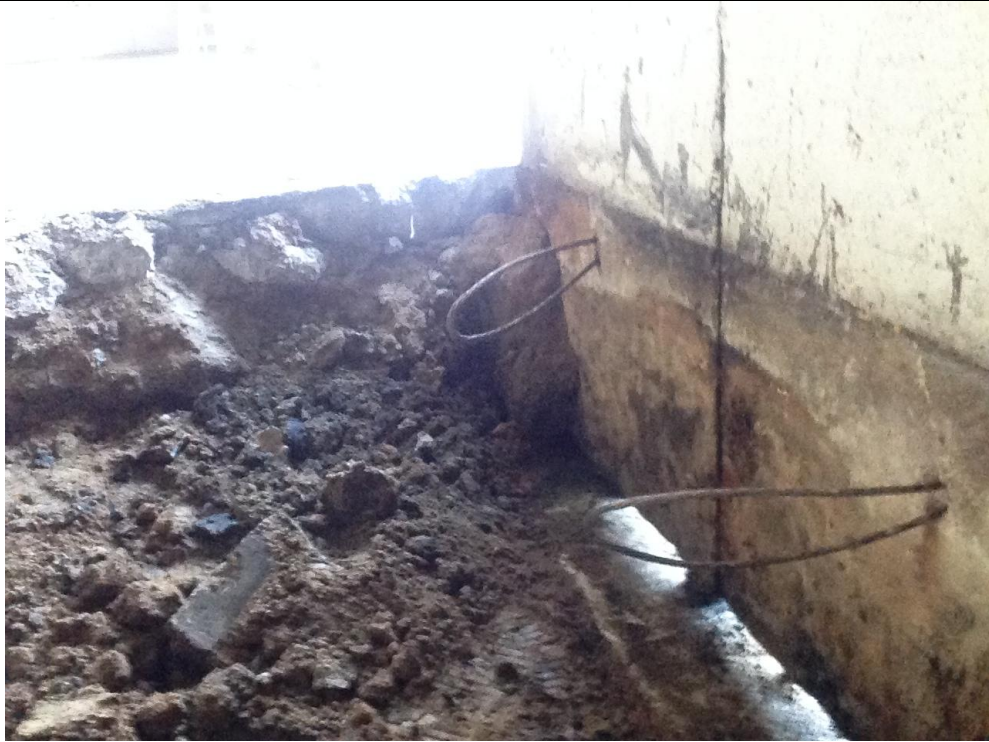
Photograph 3: South side of the test pad with cables that were found to be embedded in the existing slab (photo taken facing west).

- Any embedded items uncovered during demolition of the slab along the wall (i.e. cables) should be protected and cast back into the new concrete slab. Please notify me if any other embedded items are discovered during demolition of the concrete along the wall.

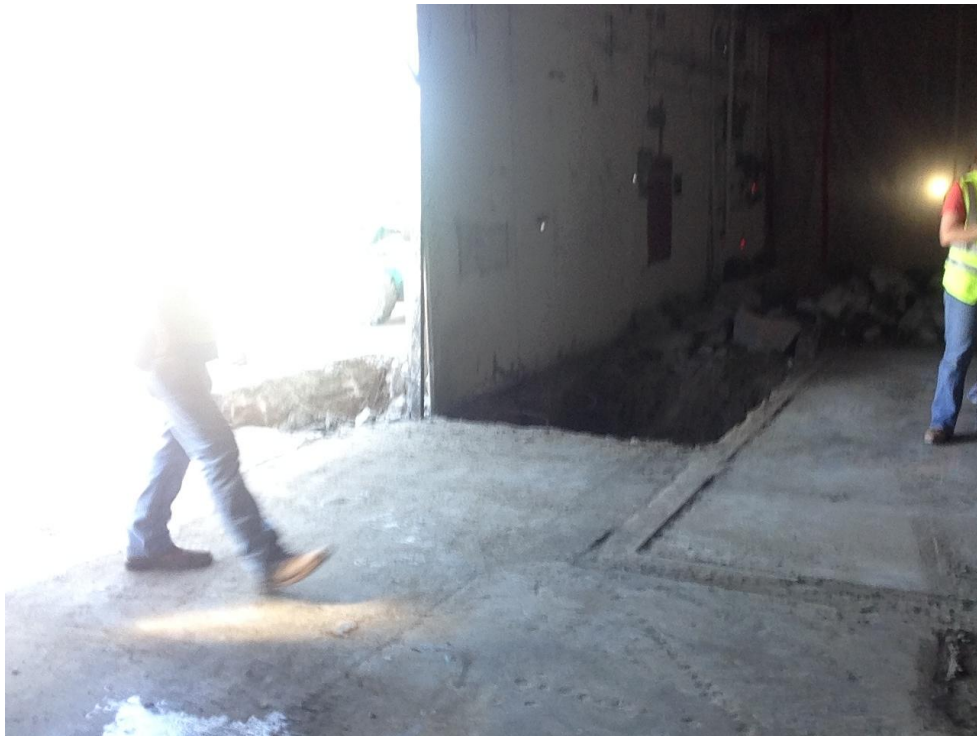
Photograph 4: Photo of test pit at panel joint. Square slab in the right side of the photo is the location of the expected deepest impacted soil, as determined from URS' 2014 drilling investigation (photo taken facing east).
